The Fire Resistance
Performance of Non-
Load Bearing, Partition
Wall Assembly with 14
sockets, Tested in
Accordance with BS
EN 1364-1: 2015

525297/R

Vexbox Ltd

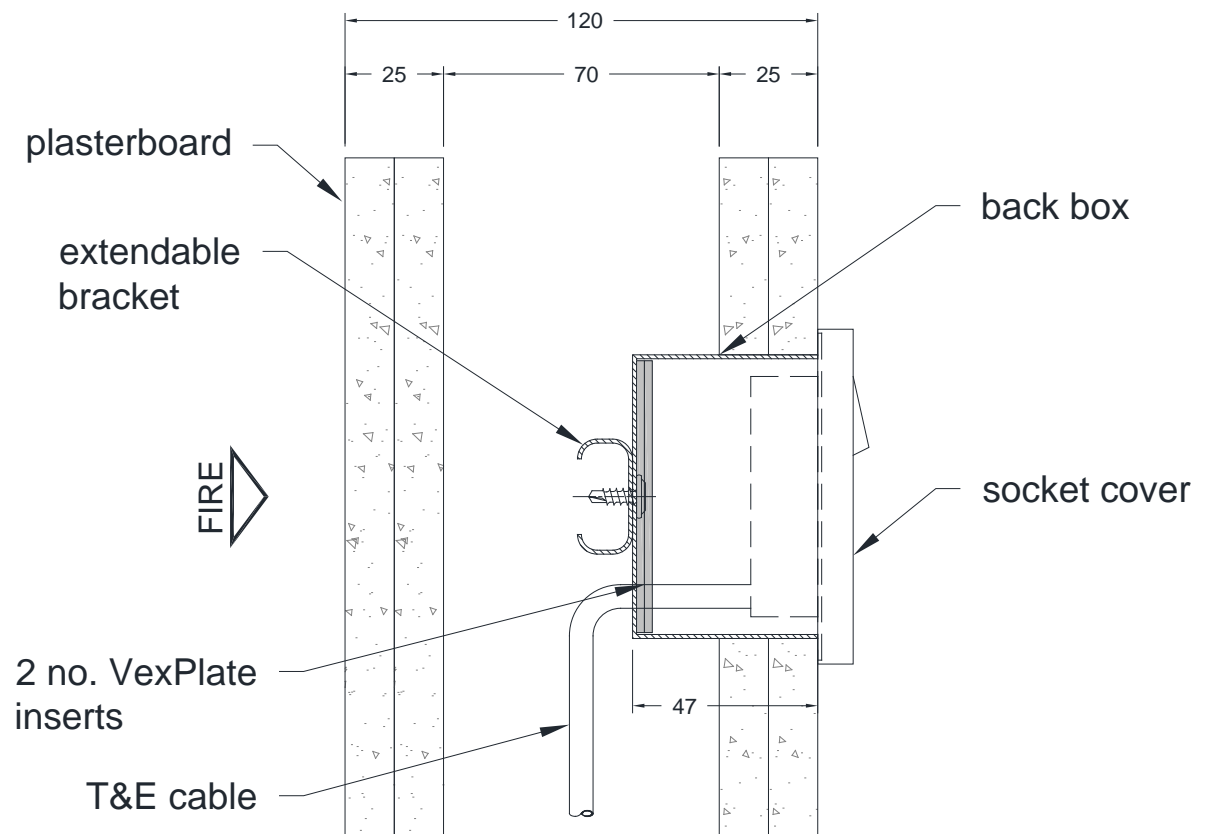
Figure 4 – Typical vertical section through specimens A and B

**TYPICAL VERTICAL SECTION
THROUGH SPECIMENS A, B**

Specimen	Aperture size and back box depth	Specimen Details
A	132 mm long x 72 mm wide x 47 mm deep x 1.0 mm thickness	Back box installed flush with the UXF. Fitted with 2x 2 mm thick 'VexPLATE', and with 1 x twin and earth cable penetrating through the back.
B		
C	132 mm long x 72 mm wide x 35 mm deep x 0.8 mm thickness	Back box installed flush with the UXF. Fitted with 1x 2 mm thick 'VexPLATE' and 1x 2 mm thick 'VexBOX' with 1 x twin and earth cable penetrating through the back.
D		
E	132 mm long x 72 mm wide x 47 mm deep x 1.0 mm thickness	Back box installed recessed 25 mm from the UXF. Fitted with 2x 2 mm thick 'VexPLATE' and 1x 2 mm thick 'VexBOX' with 1 x twin and earth cable penetrating through the base.
F		
G	132 mm long x 72 mm wide x 35 mm deep x 0.8 mm thickness	Back box installed recessed 25 mm from the UXF. Fitted with 1x 2 mm thick 'VexPLATE' and 1x 2 mm thick 'VexBOX' with 1 x twin and earth cable penetrating through the base.

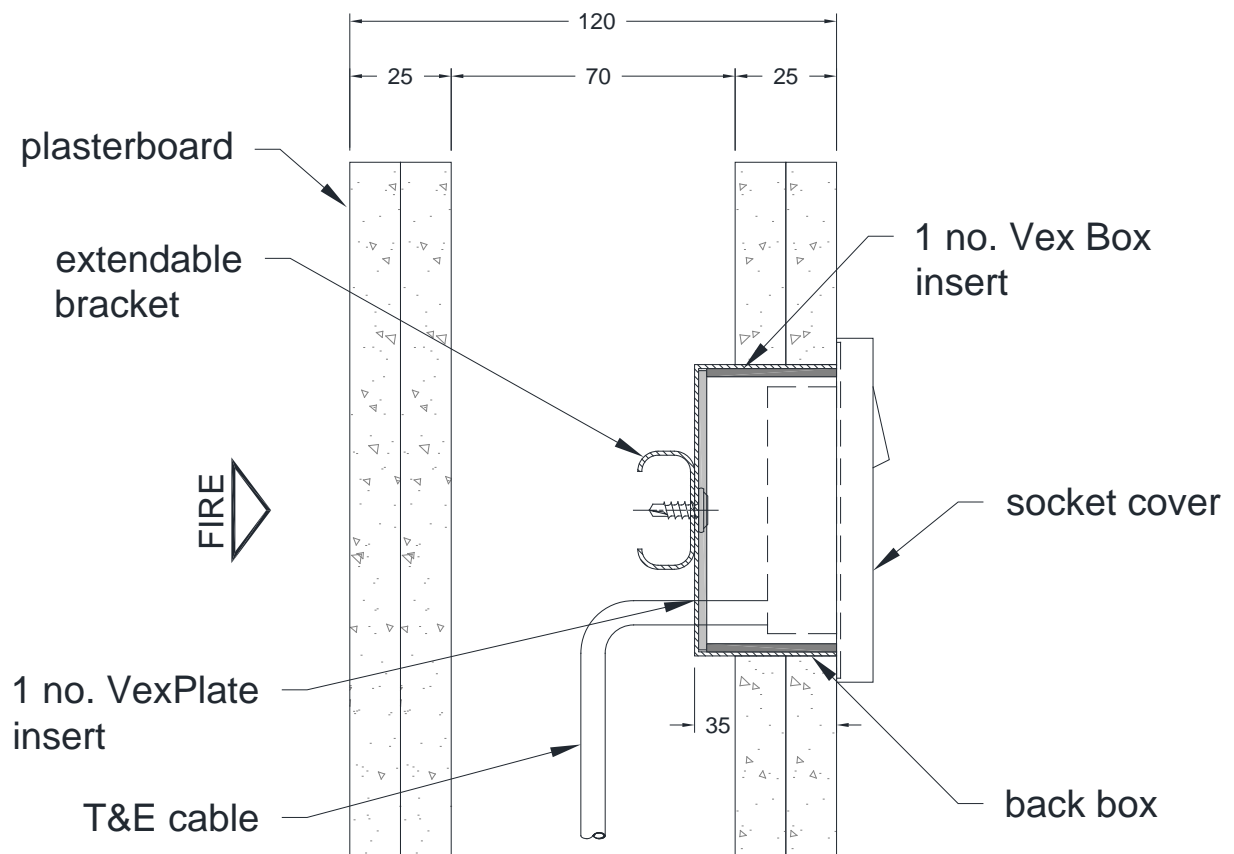
Figure 5 – Typical vertical section through specimens C and D

**TYPICAL VERTICAL SECTION
THROUGH SPECIMENS C, D**

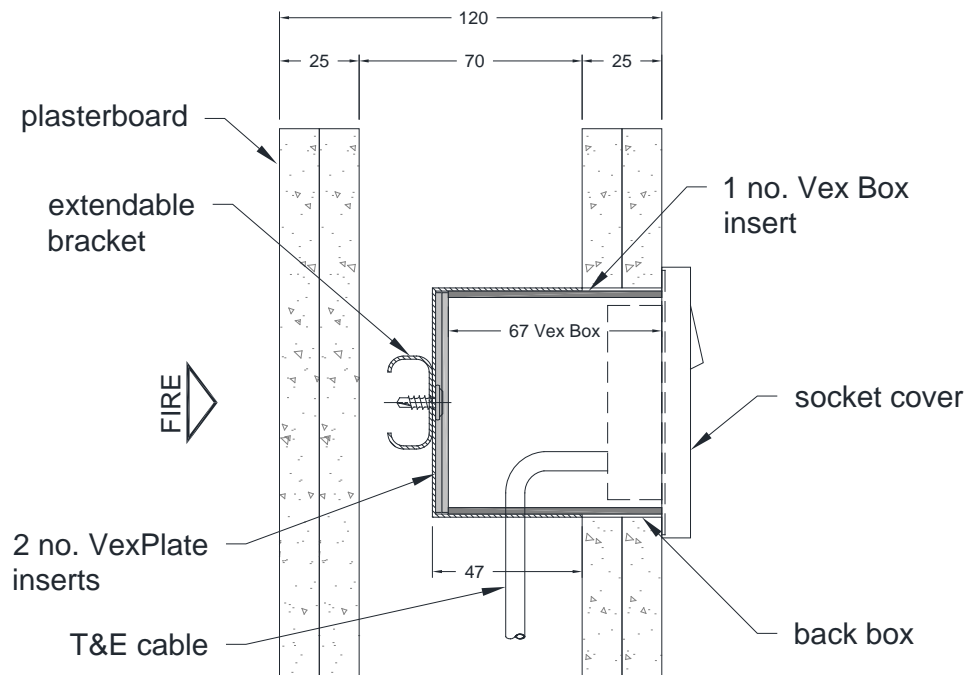
Figure 6 – Typical vertical section through specimens E and F

TYPICAL VERTICAL SECTION
THROUGH SPECIMENS E, F

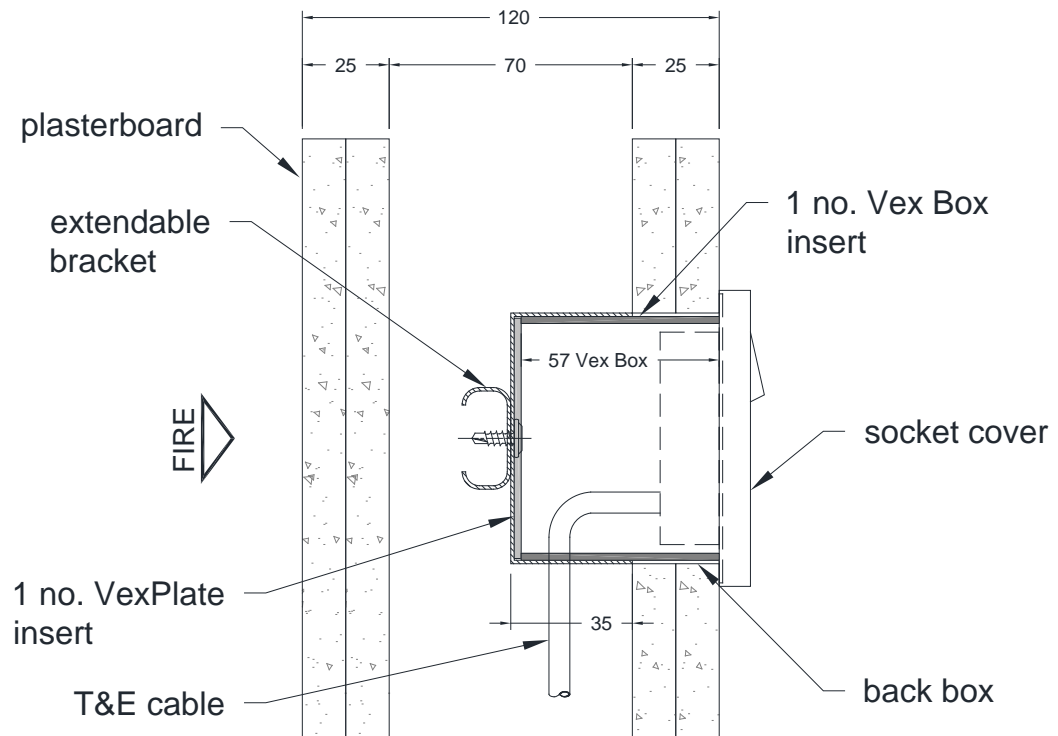
Figure 7 – Typical vertical section through specimens G and H

**TYPICAL VERTICAL SECTION
THROUGH SPECIMENS G, H**

H		
I	132 mm long x 72 mm wide x 47 mm deep x 1.0 mm thickness	Back box installed recessed 35 mm from the UXF. Fitted with 2x 2 mm thick 'VexPLATE' and 1x 2 mm thick 'VexBOX' with 1 x twin and earth cable penetrating through the base, and through a 20 mm diameter plastic conduit with 1.5 mm wall thickness. The 'VexBOX' template was wrapped in class H glass cloth tape.
J

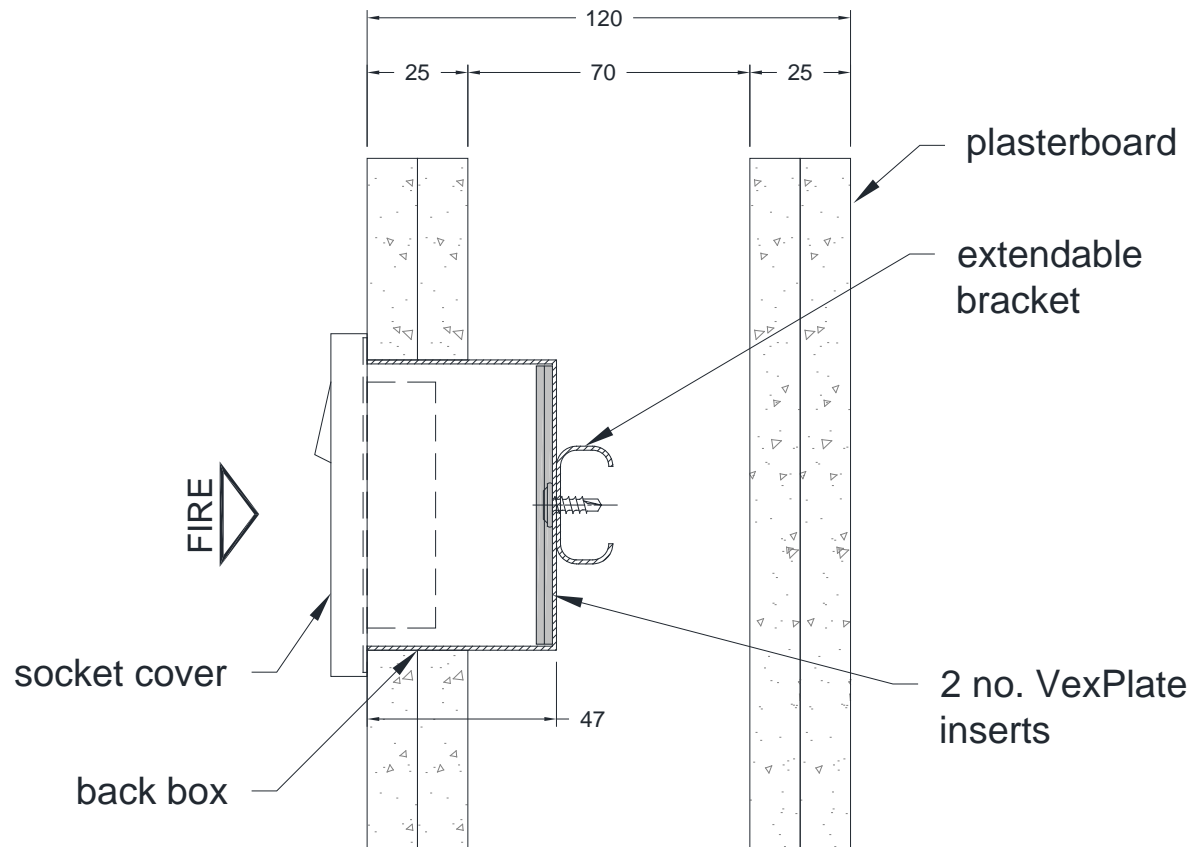
Figure 10 – Typical vertical section through specimen M

**TYPICAL VERTICAL SECTION
THROUGH SPECIMEN M**

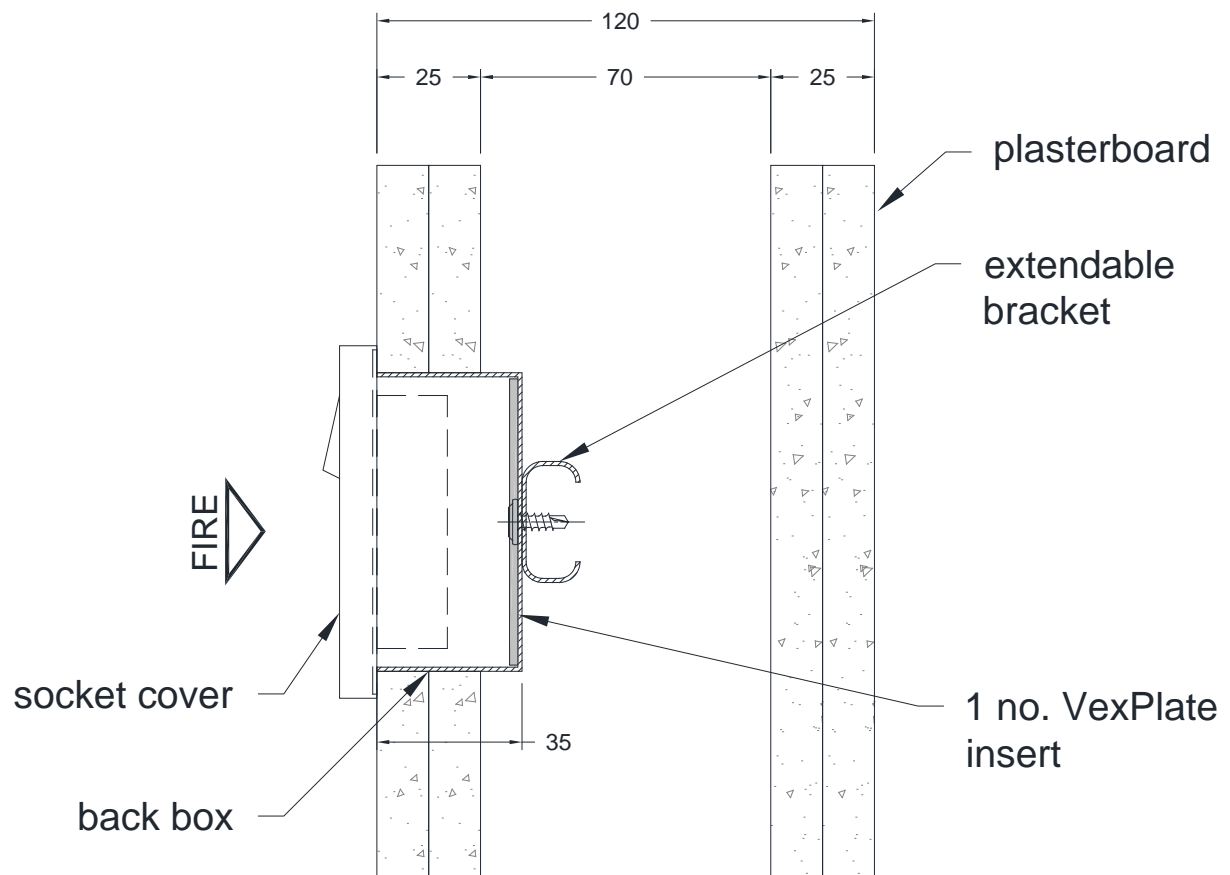
Figure 11 – Typical vertical section through specimen N

**TYPICAL VERTICAL SECTION
THROUGH SPECIMEN N**

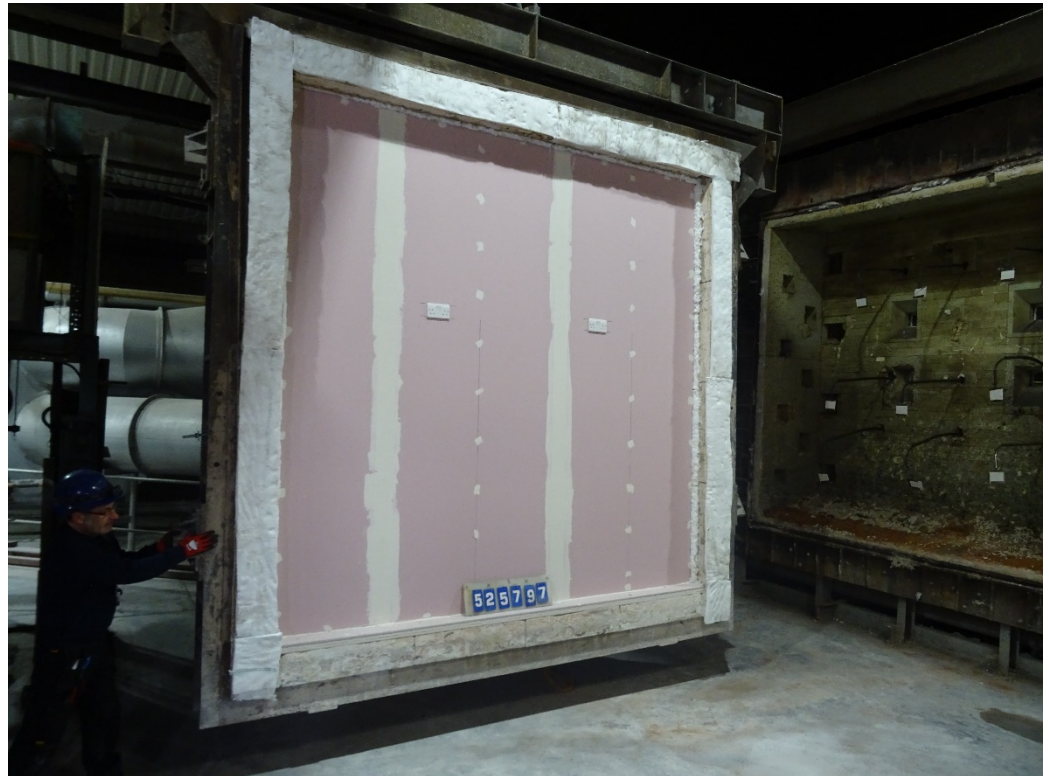
The exposed face of the specimen prior to testing

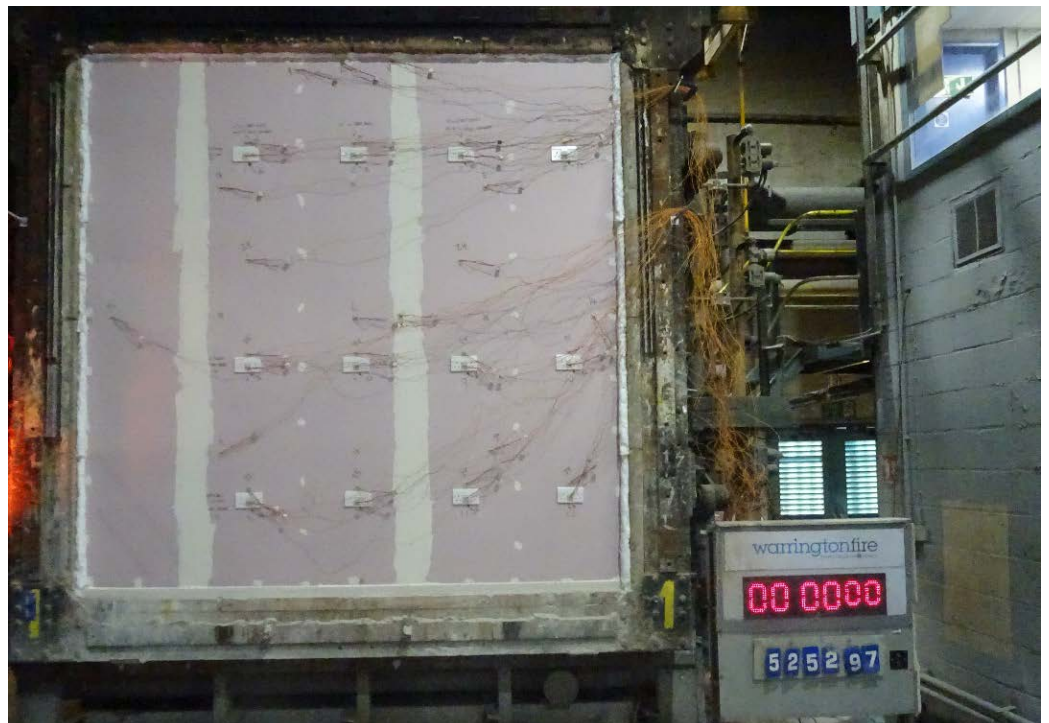
The unexposed face of the specimen prior to testing

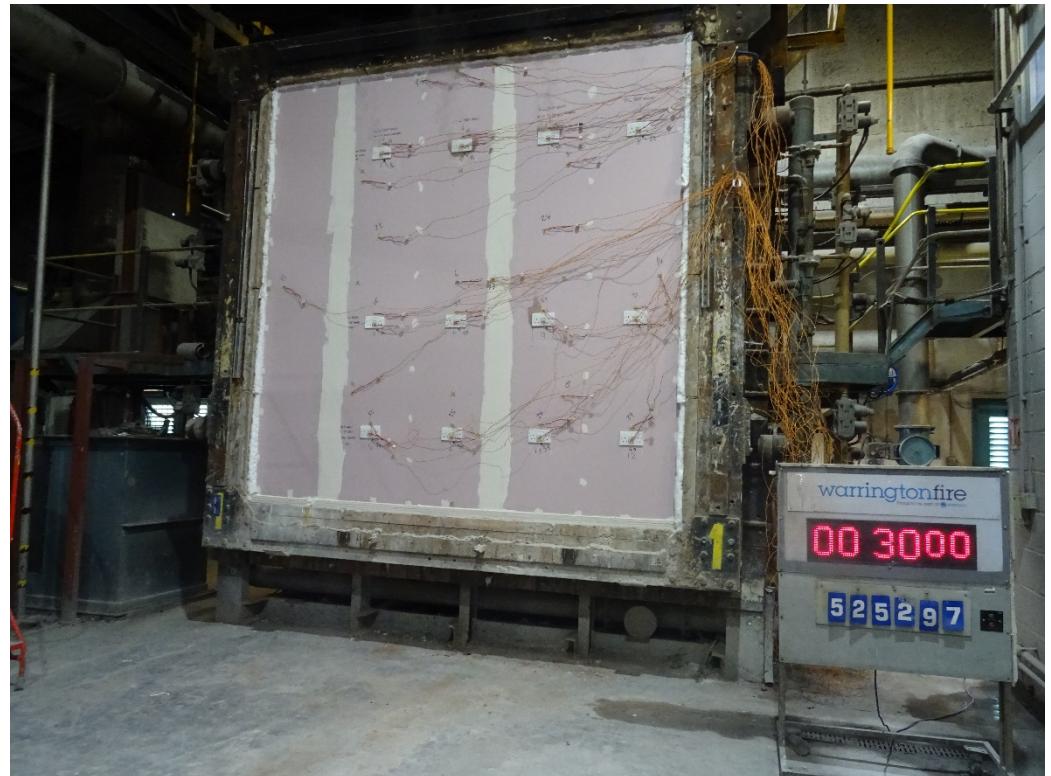
The unexposed face of the specimen after a test duration of 30 minutes

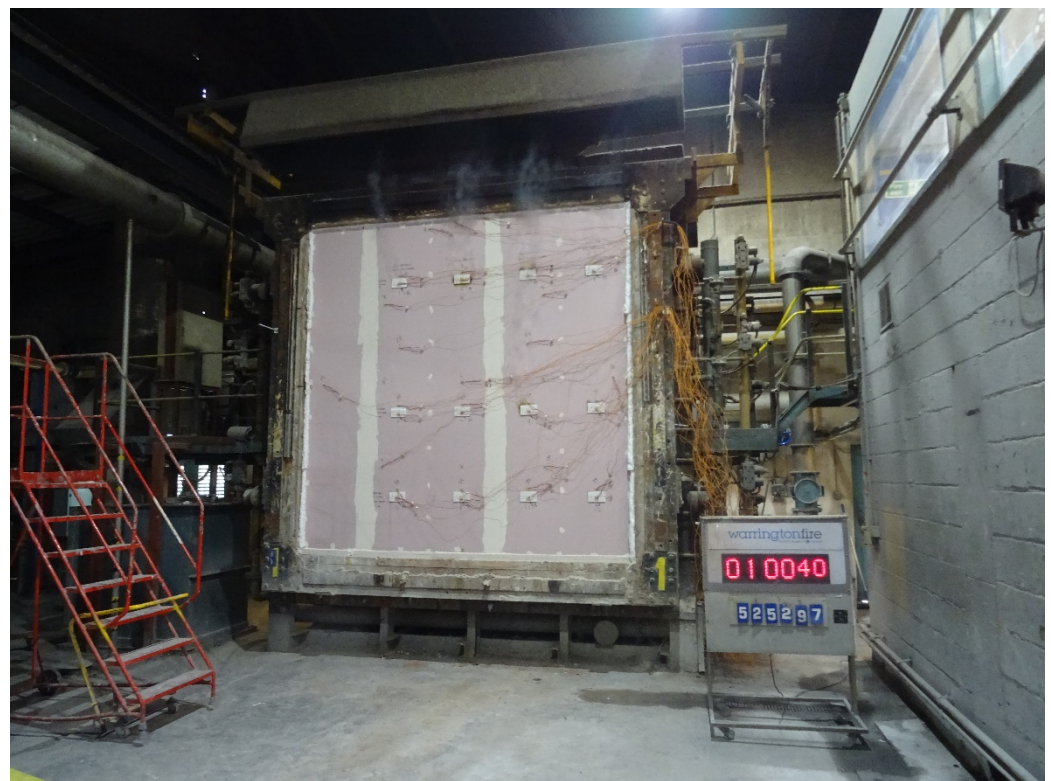
The unexposed face of the specimen after a test duration of 60 minutes

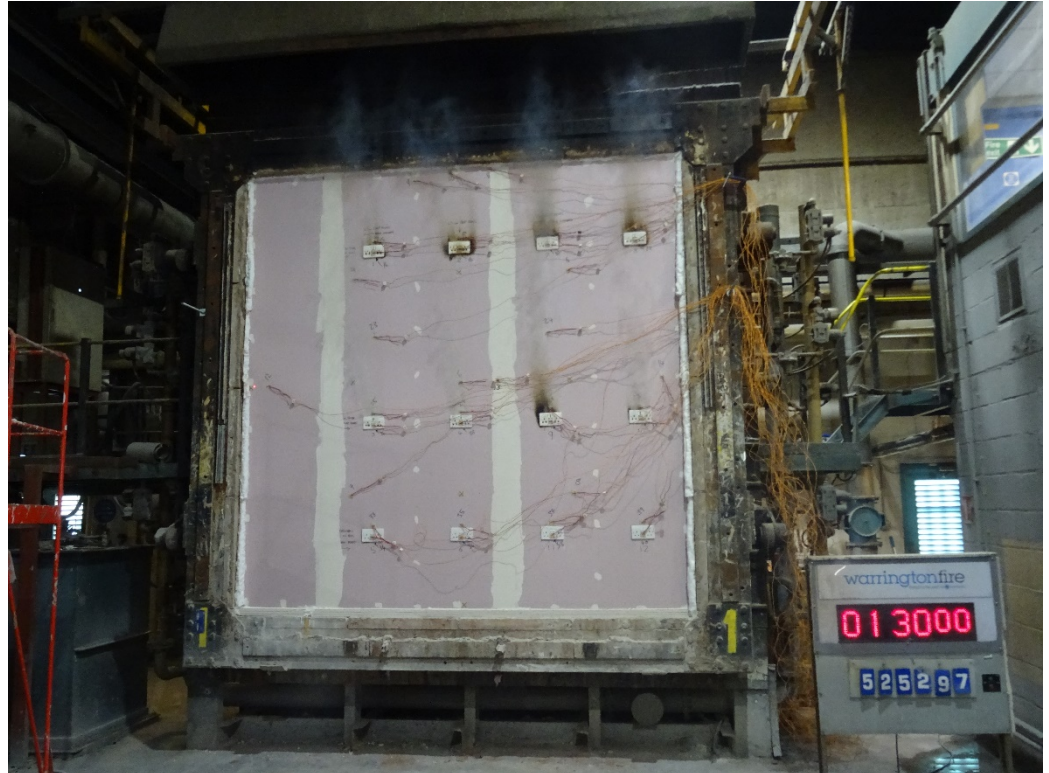
The unexposed
face of the
specimen after a
test duration of
90 minutes

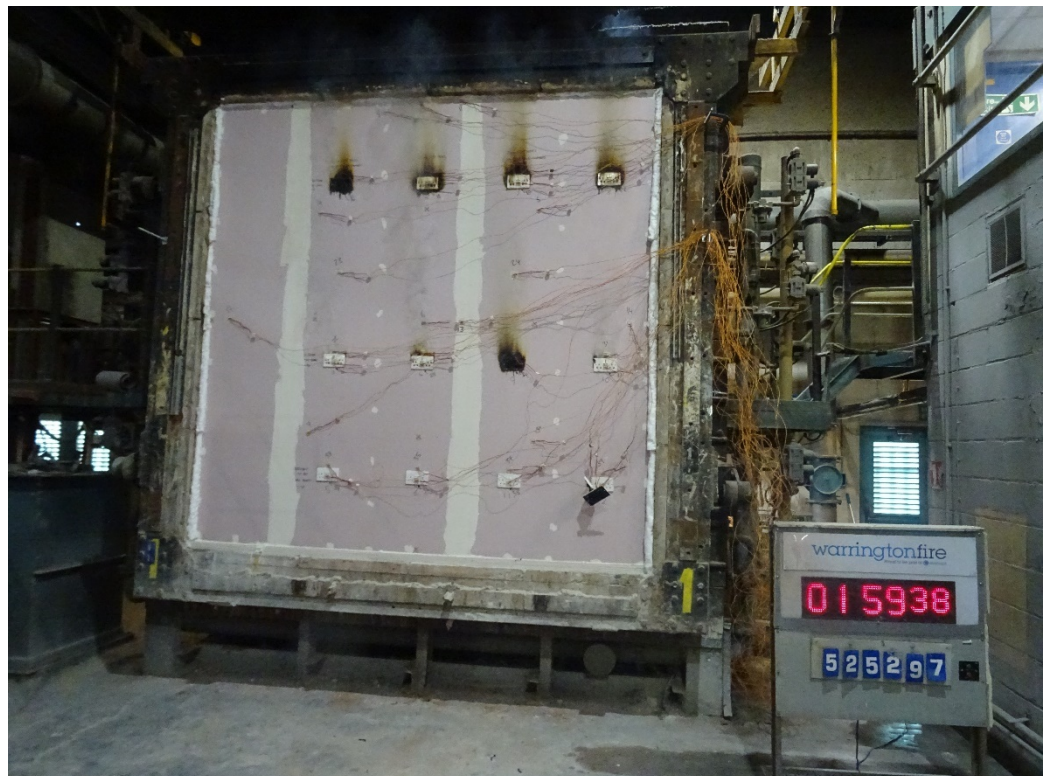
The unexposed
face of the
specimen after a
test duration of
119 minutes

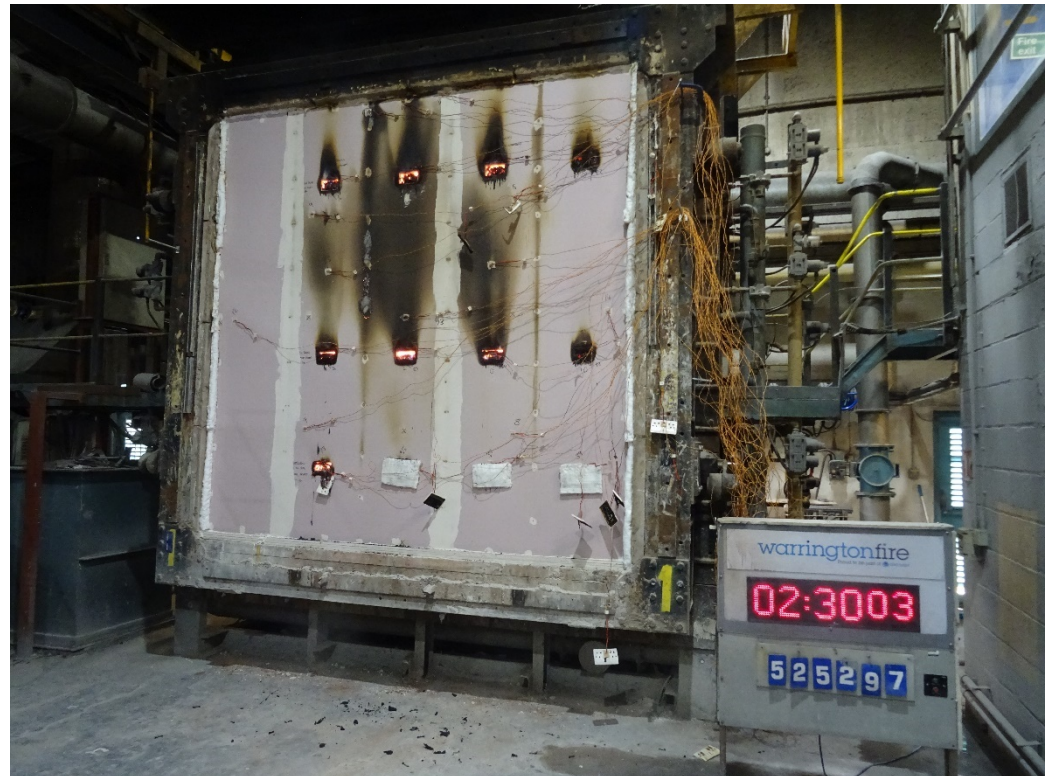
The unexposed face of the specimen after a test duration of 150 minutes

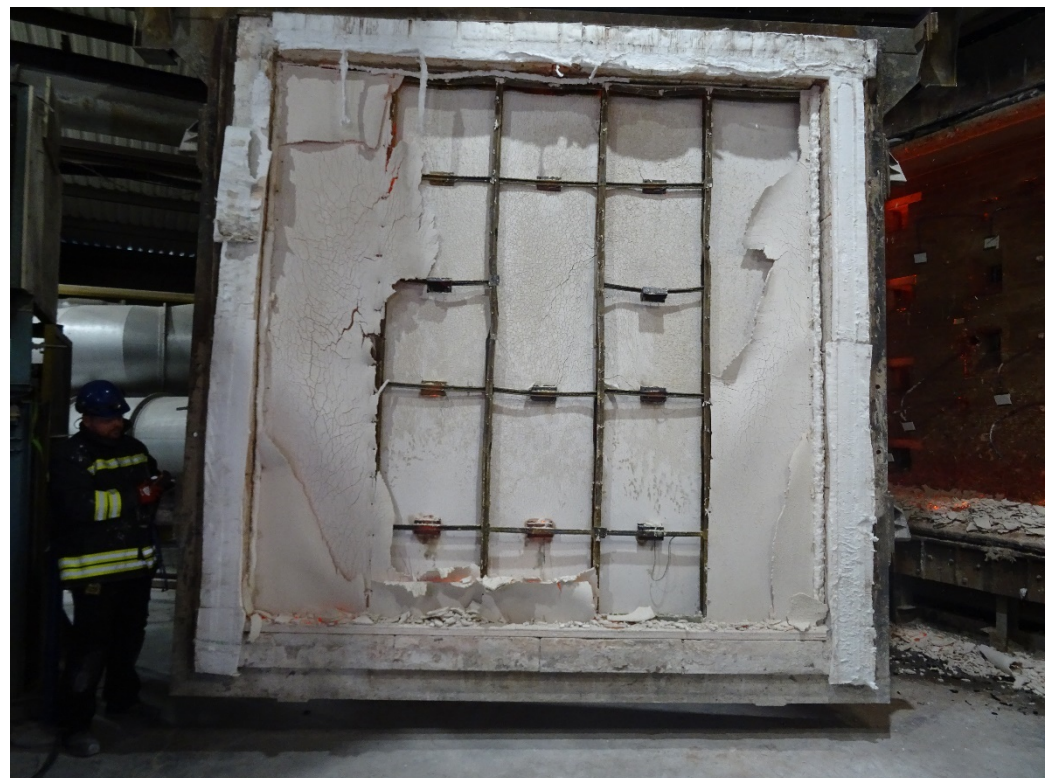
The exposed face of the specimen immediately after the test

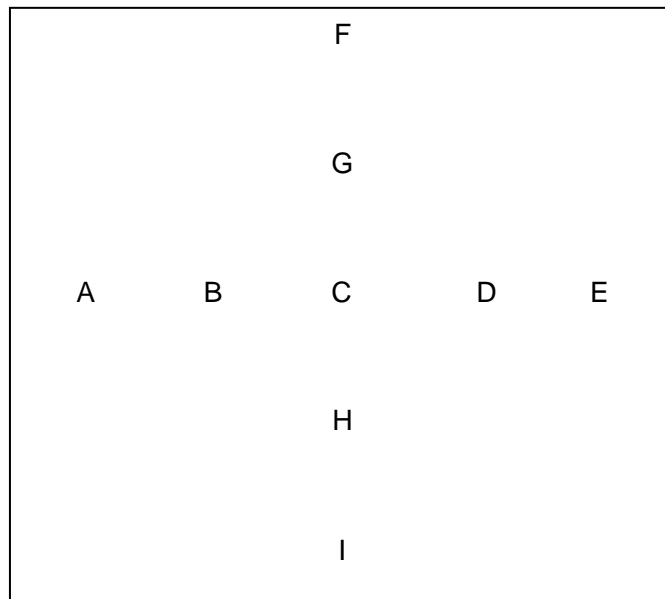
Deflection Of The Specimen During The Test

Positive deflections indicate movement towards the furnace chamber

TIME mins	A	B	C	D	E	F	G	H	I
0	0	0	0	0	0	0	0	0	0
10	-6	0	-5	-3	-10	-9	10	10	0
20	0	6	1	3	-3	2	2	6	3
30	-4	-2	-8	-2	-10	1	6	6	5
40	-1	8	0	9	2	-15	14	-1	6
50	-5	15	7	11	-8	-7	22	18	8
60	19	35	25	27	-4	-3	22	25	9
70	22	38	23	27	-1	-8	22	26	8
80	25	35	32	30	-39	-6	25	23	1
90	28	29	21	22	0	-8	22	15	-10
100	7	30	29	26	-1	-6	25	21	-7
110	6	35	26	27	3	-15	24	26	-5
120	0	30	30	26	1	-15	29	29	-3
130	5	33	38	28	0	0	24	32	-6
140	16	27	16	29	4	-12	7	24	-9

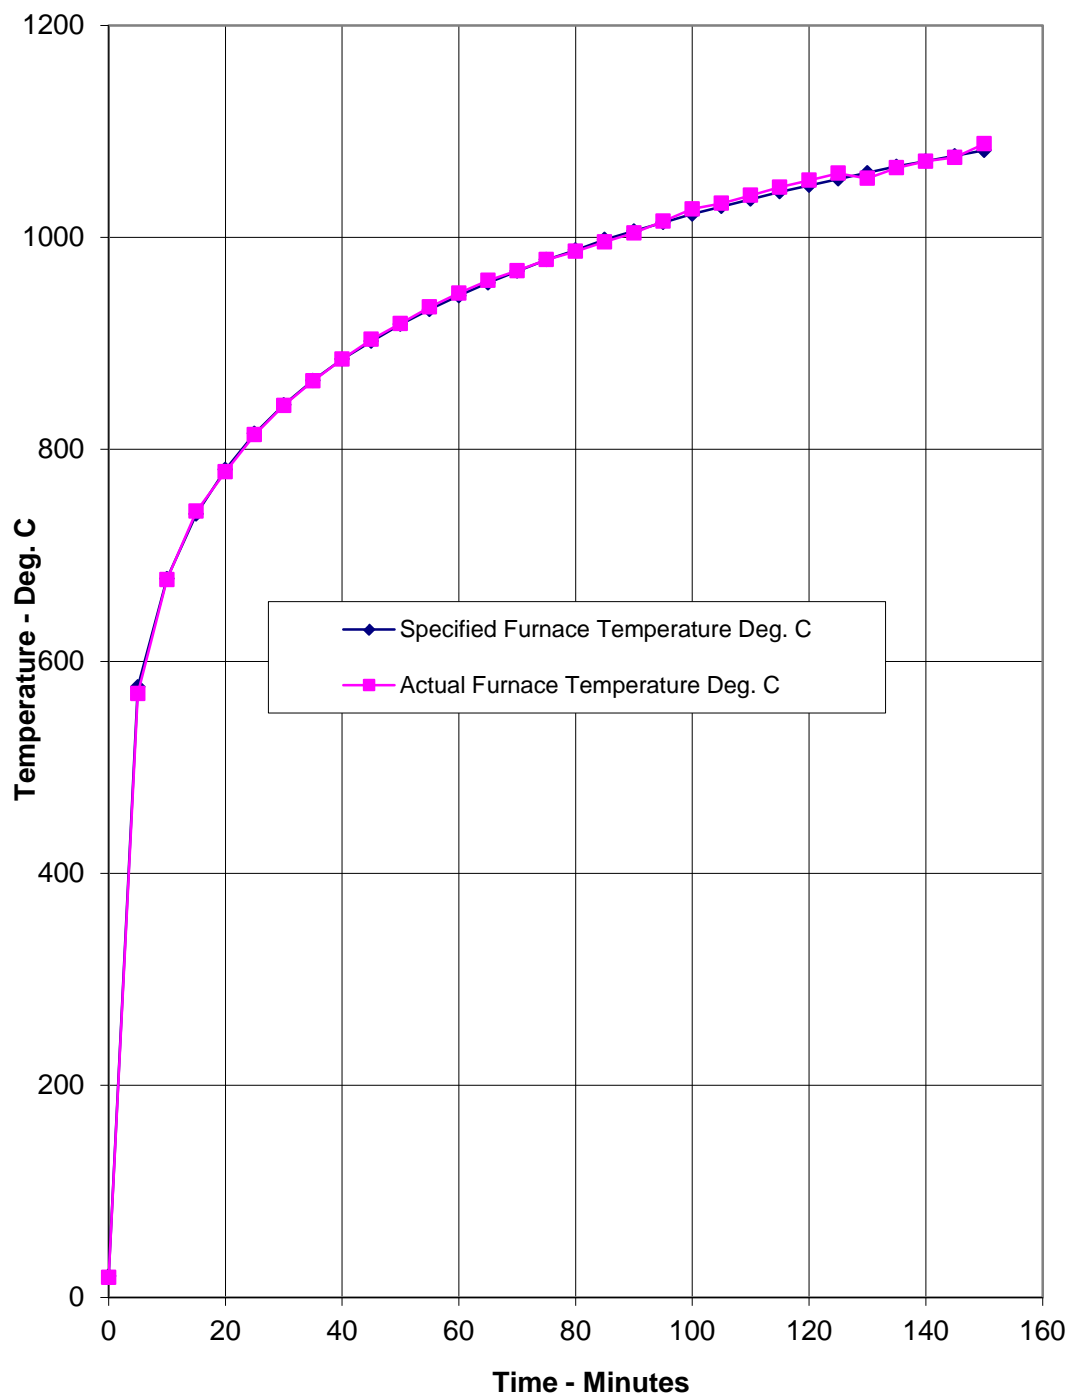
Graph Showing Mean Furnace Temperature, Together With The Temperature/Time Relationship Specified In The Standard BS EN 1363-1: 2020

Time Mins	Specified Furnace Temperature Deg. C	Actual Furnace Temperature Deg. C
0	20	19
5	576	570
10	678	677
15	739	742
20	781	779
25	815	814
30	842	841
35	865	865
40	885	885
45	902	904
50	918	919
55	932	934
60	945	947
65	957	959
70	968	969
75	979	979
80	988	987
85	998	996
90	1006	1004
95	1014	1015
100	1022	1027
105	1029	1032
110	1036	1040
115	1043	1047
120	1049	1054
125	1055	1060
130	1061	1056
135	1067	1066
140	1072	1072
145	1077	1075
150	1082	1088

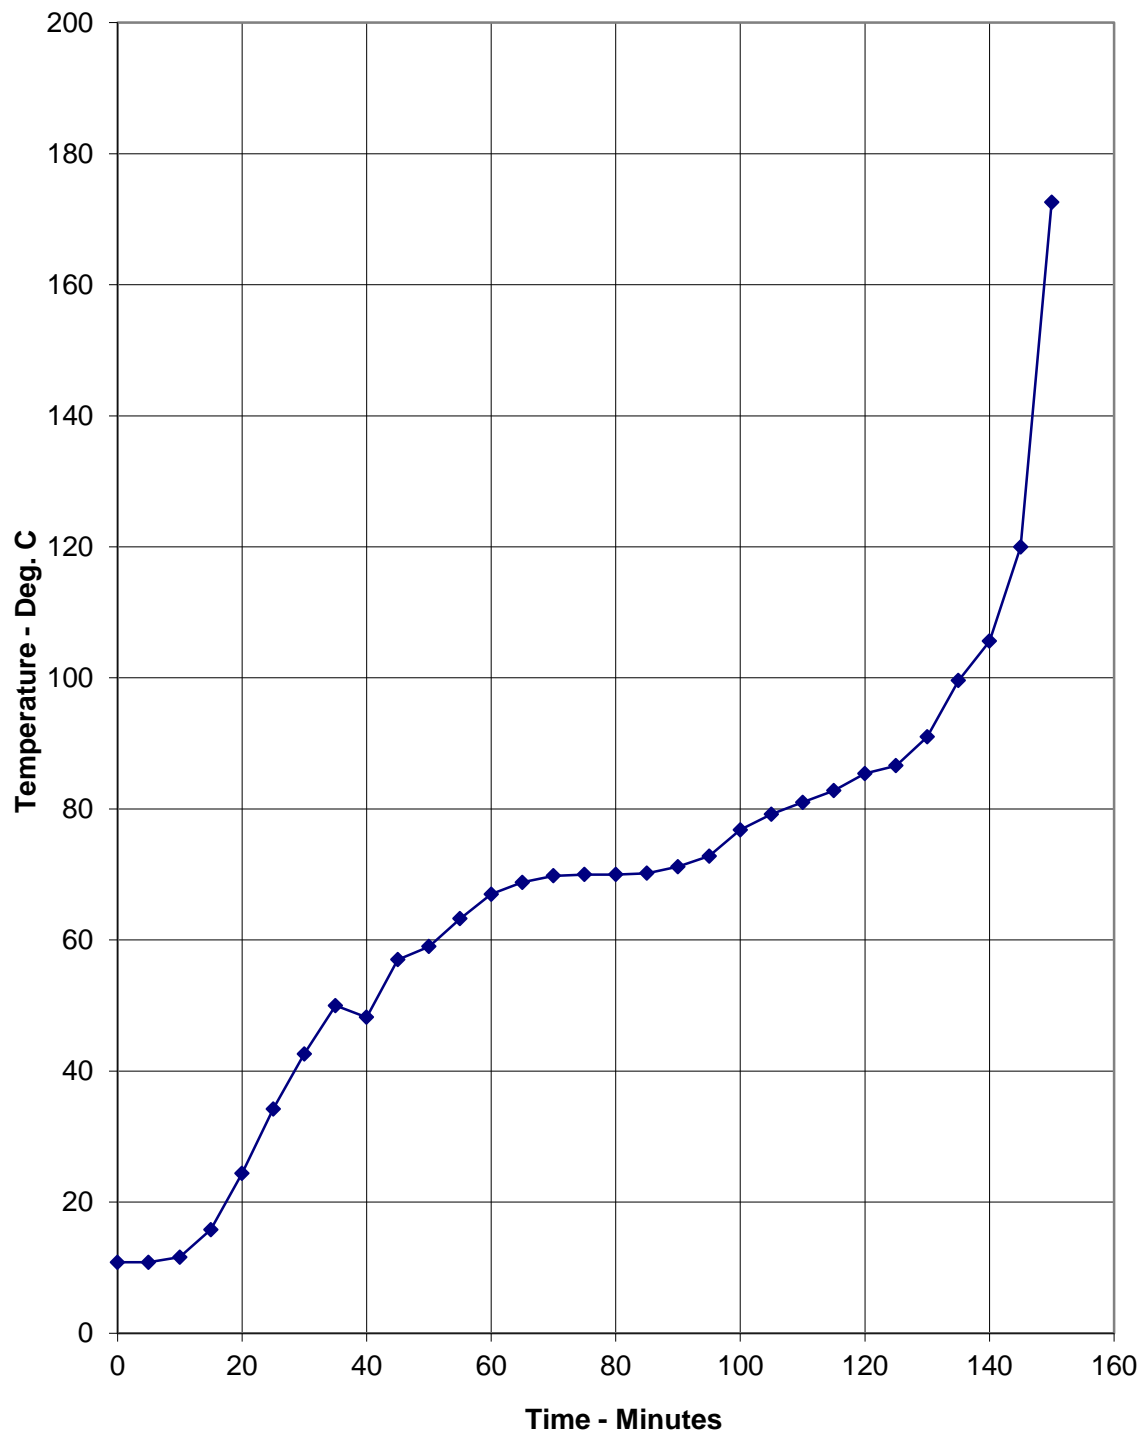
Graph Showing Mean Temperature Recorded On The Unexposed Surface Of The Specimen

Time Mins	T/C Number 4 Deg. C	T/C Number 5 Deg. C	T/C Number 6 Deg. C	T/C Number 7 Deg. C	T/C Number 8 Deg. C	Mean Temp Deg. C
0	11	11	11	11	10	11
5	11	11	11	11	10	11
10	12	12	12	11	11	12
15	18	18	15	15	13	16
20	29	28	24	22	19	24
25	40	38	34	32	27	34
30	49	46	43	40	35	43
35	55	53	51	48	43	50
40	25	56	56	55	49	48
45	*	58	58	58	54	57
50	*	60	59	60	57	59
55	*	64	64	63	62	63
60	*	68	67	68	65	67
65	69	70	68	70	67	69
70	70	71	68	71	69	70
75	70	71	68	71	70	70
80	70	70	69	71	70	70
85	71	71	69	70	70	70
90	72	72	71	71	70	71
95	73	77	72	72	70	73
100	79	79	77	74	75	77
105	80	82	78	78	78	79
110	82	84	79	80	80	81
115	84	85	81	82	82	83
120	85	87	87	84	84	85
125	87	88	88	85	85	87
130	90	92	97	87	89	91
135	101	103	106	89	99	100
140	107	108	113	94	106	106
145	115	119	151	102	113	120
146	118	123	166	103	115	125
147	123	135	197	105	117	135
150	162	179	265	112	145	173

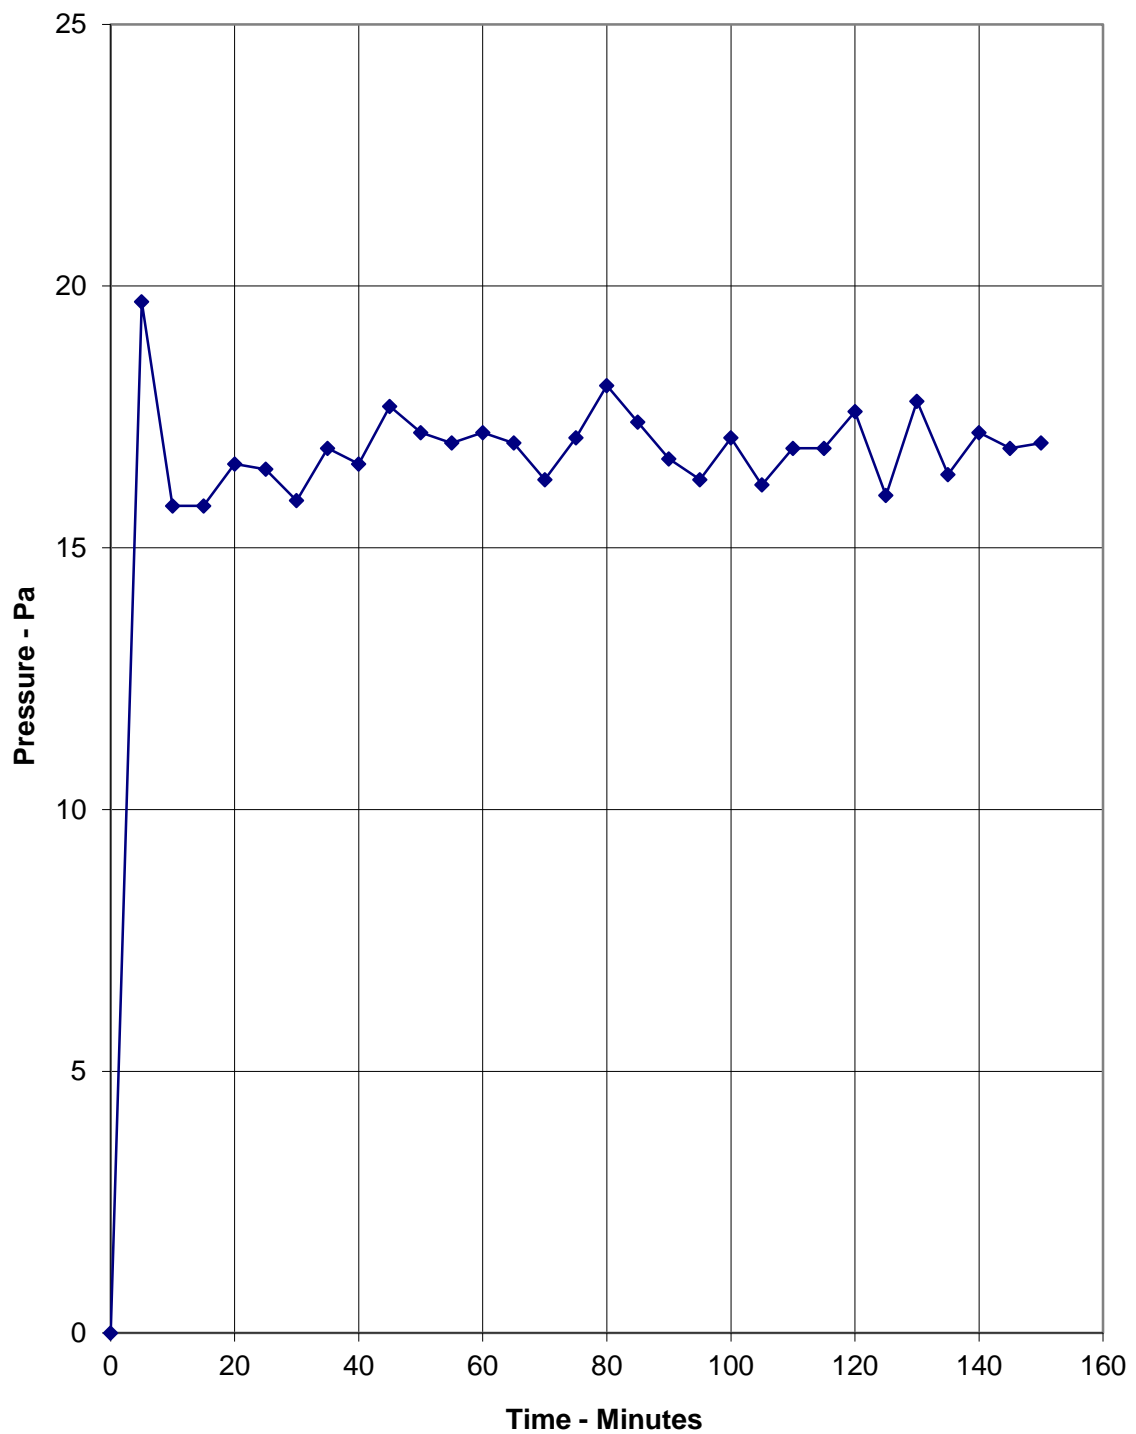
Graph Showing Recorded Furnace Pressure 300 mm Below The Head Of The Specimen
